TS-PIC-9809925S/9909925S
December 1998

AERIAL PHOTOGRAPHIC ANALYSIS WASTE DISPOSAL, INC., SITE Santa Fe Springs, California Report 1 - Hazardous Waste Site Characterization, Main Site

D. R. Williams
Environmental Services Division
Lockheed Environmental Systems & Technologies Co.
Las Vegas, Nevada 89119

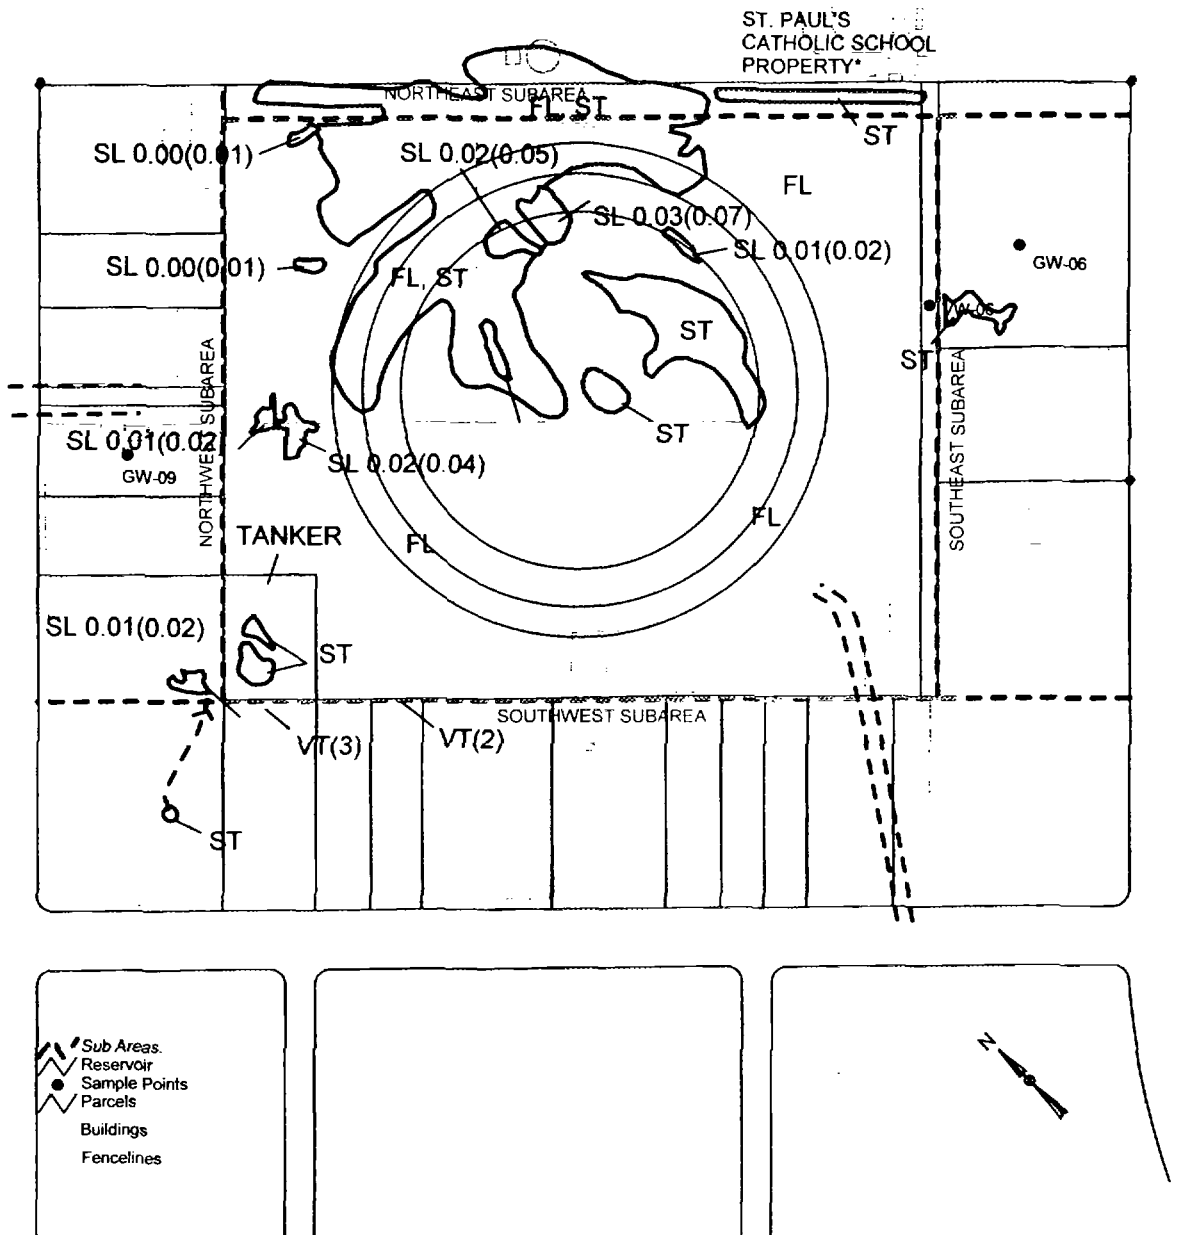
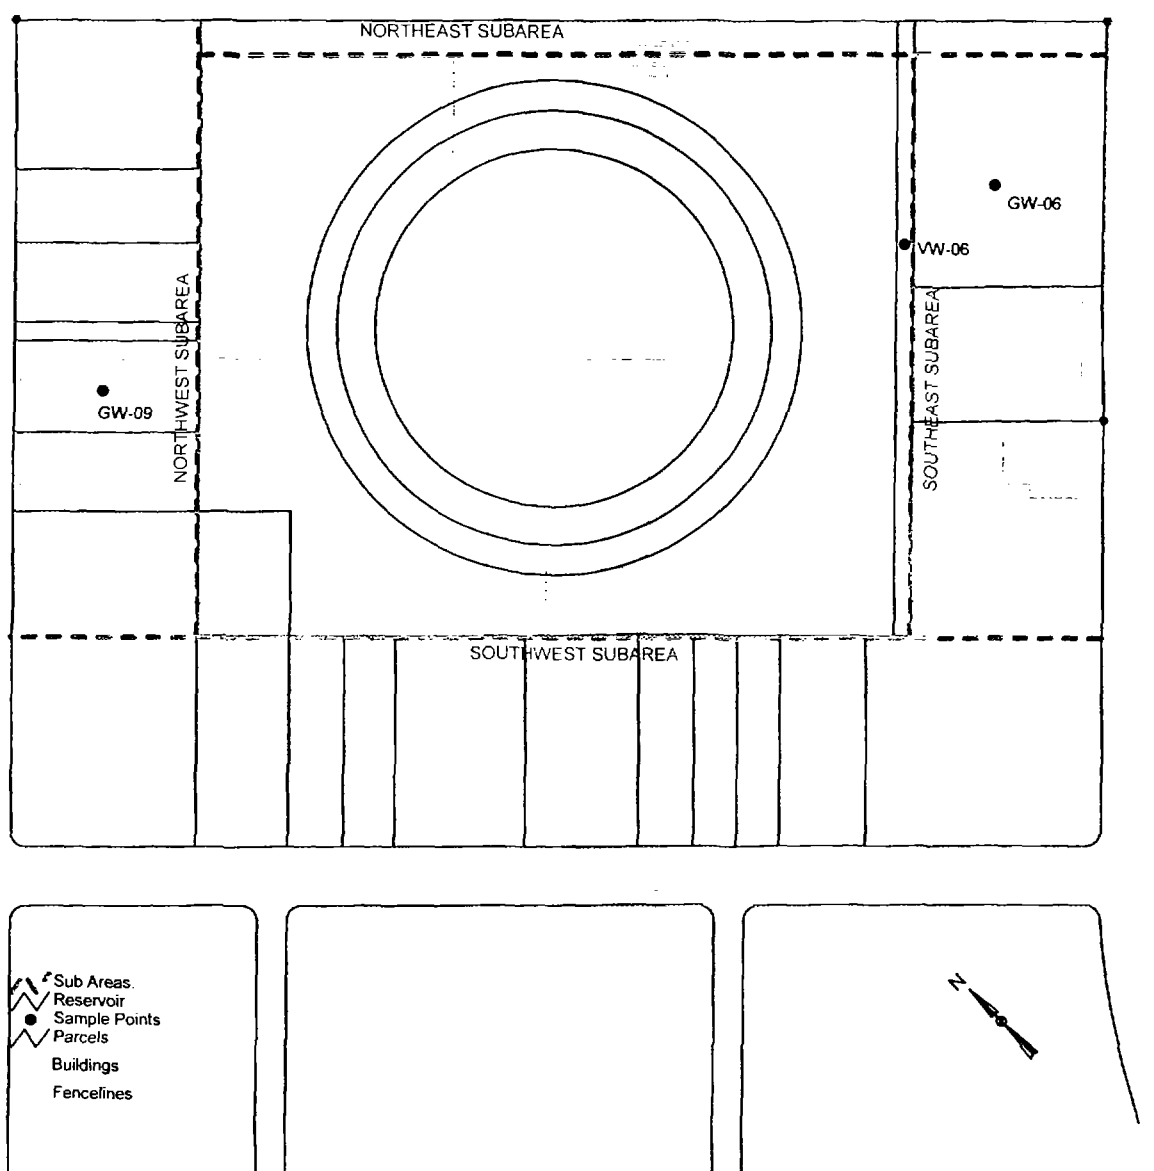
Figure 14. Waste Disposal, Inc., site map, February 28, 1963. Approximate scale 1:3,850.

Staining is evident to the northeast of the site and adjacent to St. Paul's Catholic School Property where standing liquid was noted in 1962.

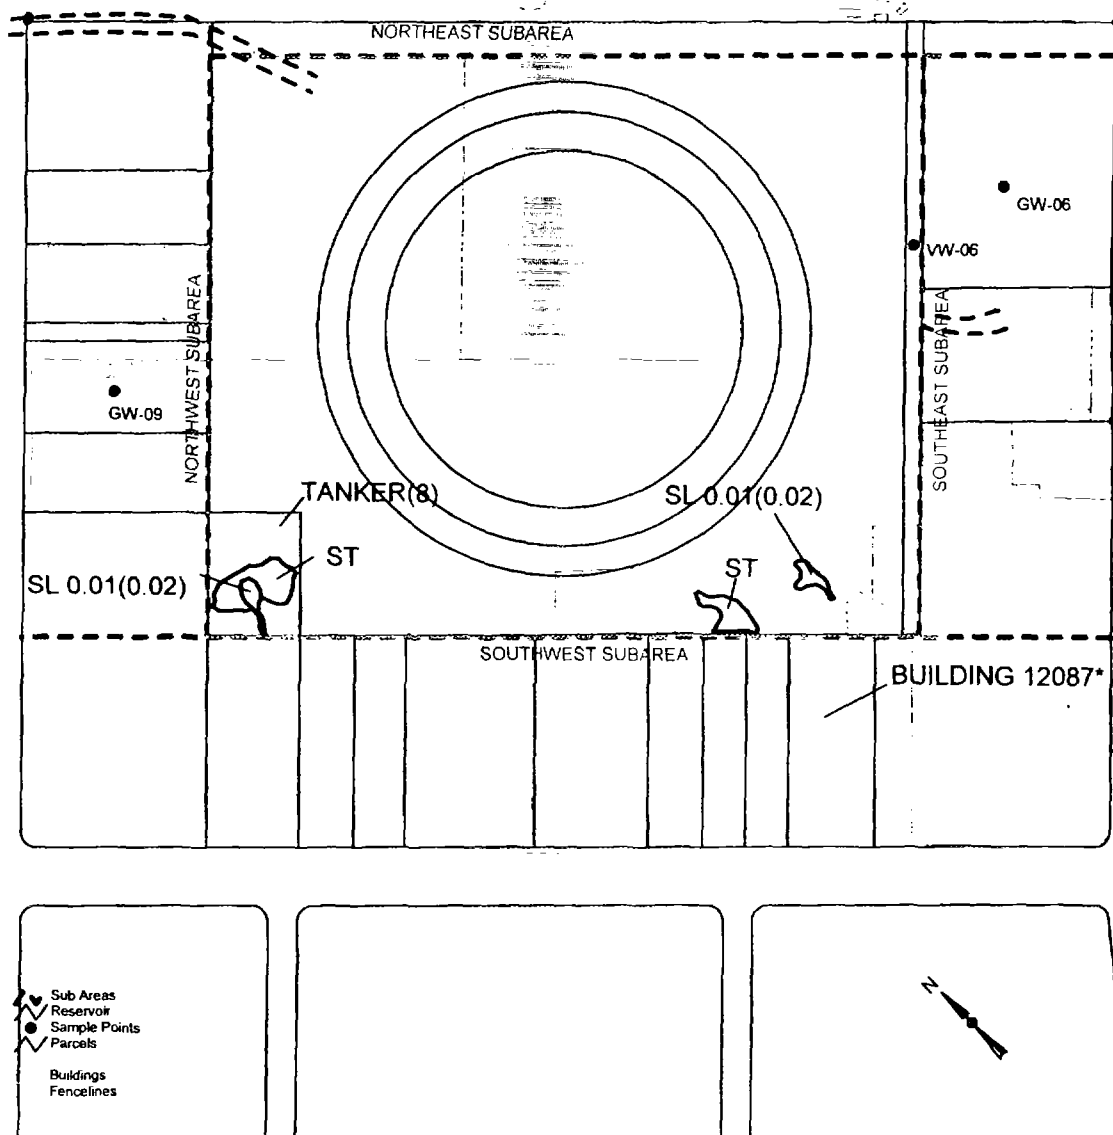
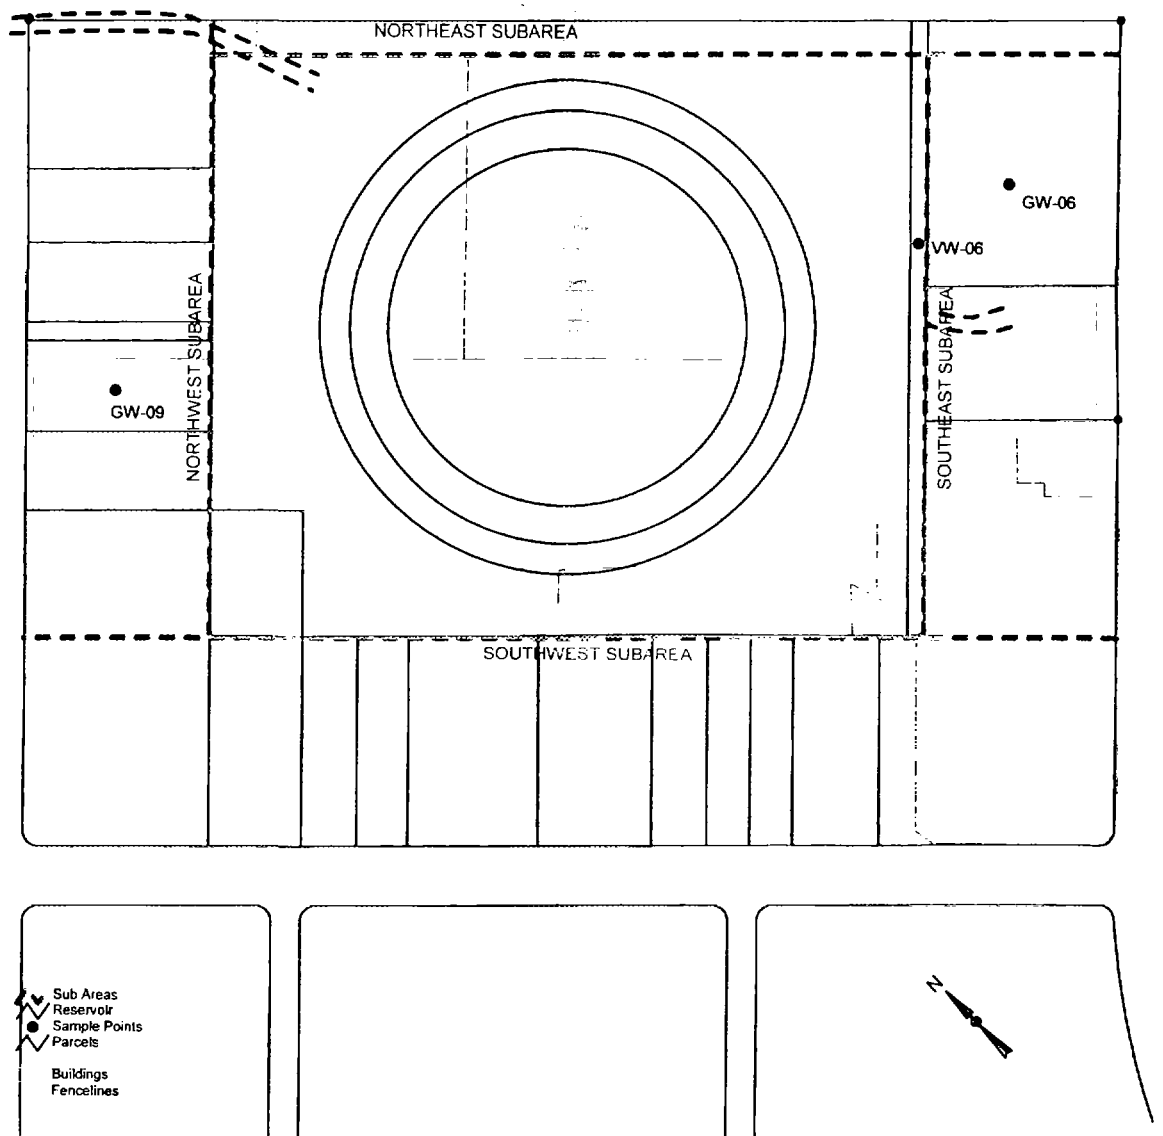
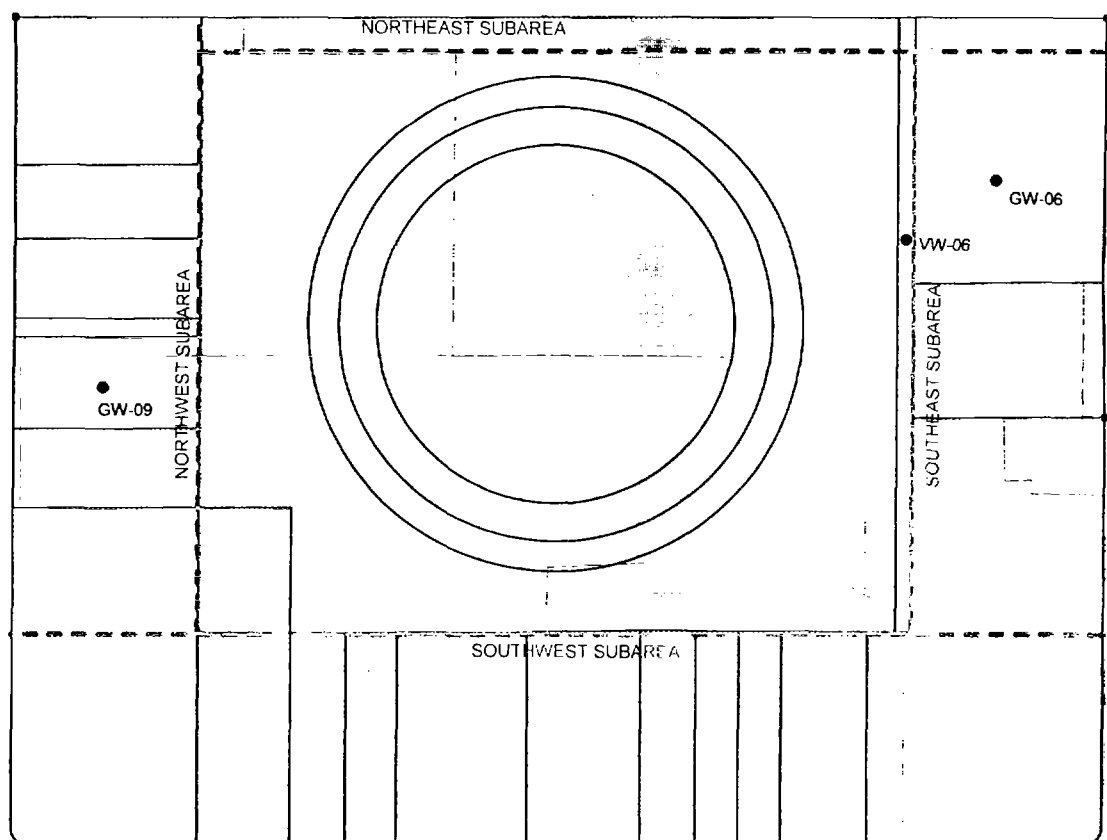
Figure 15. Waste Disposal, Inc., site map, September 23, 1968. Approximate scale 1:3,850.

Standing liquid and staining are observed near the northeast end of Building 12087*. Standing liquid and staining are seen in the western corner of the site. Resolution of the 1968 photographs precludes observation of the three vertical storage tanks seen at this location in 1963. No observation of the ditch adjacent to Parcel 4 (seen in 1963) was possible due to a parking lot constructed after 1963 in the area.

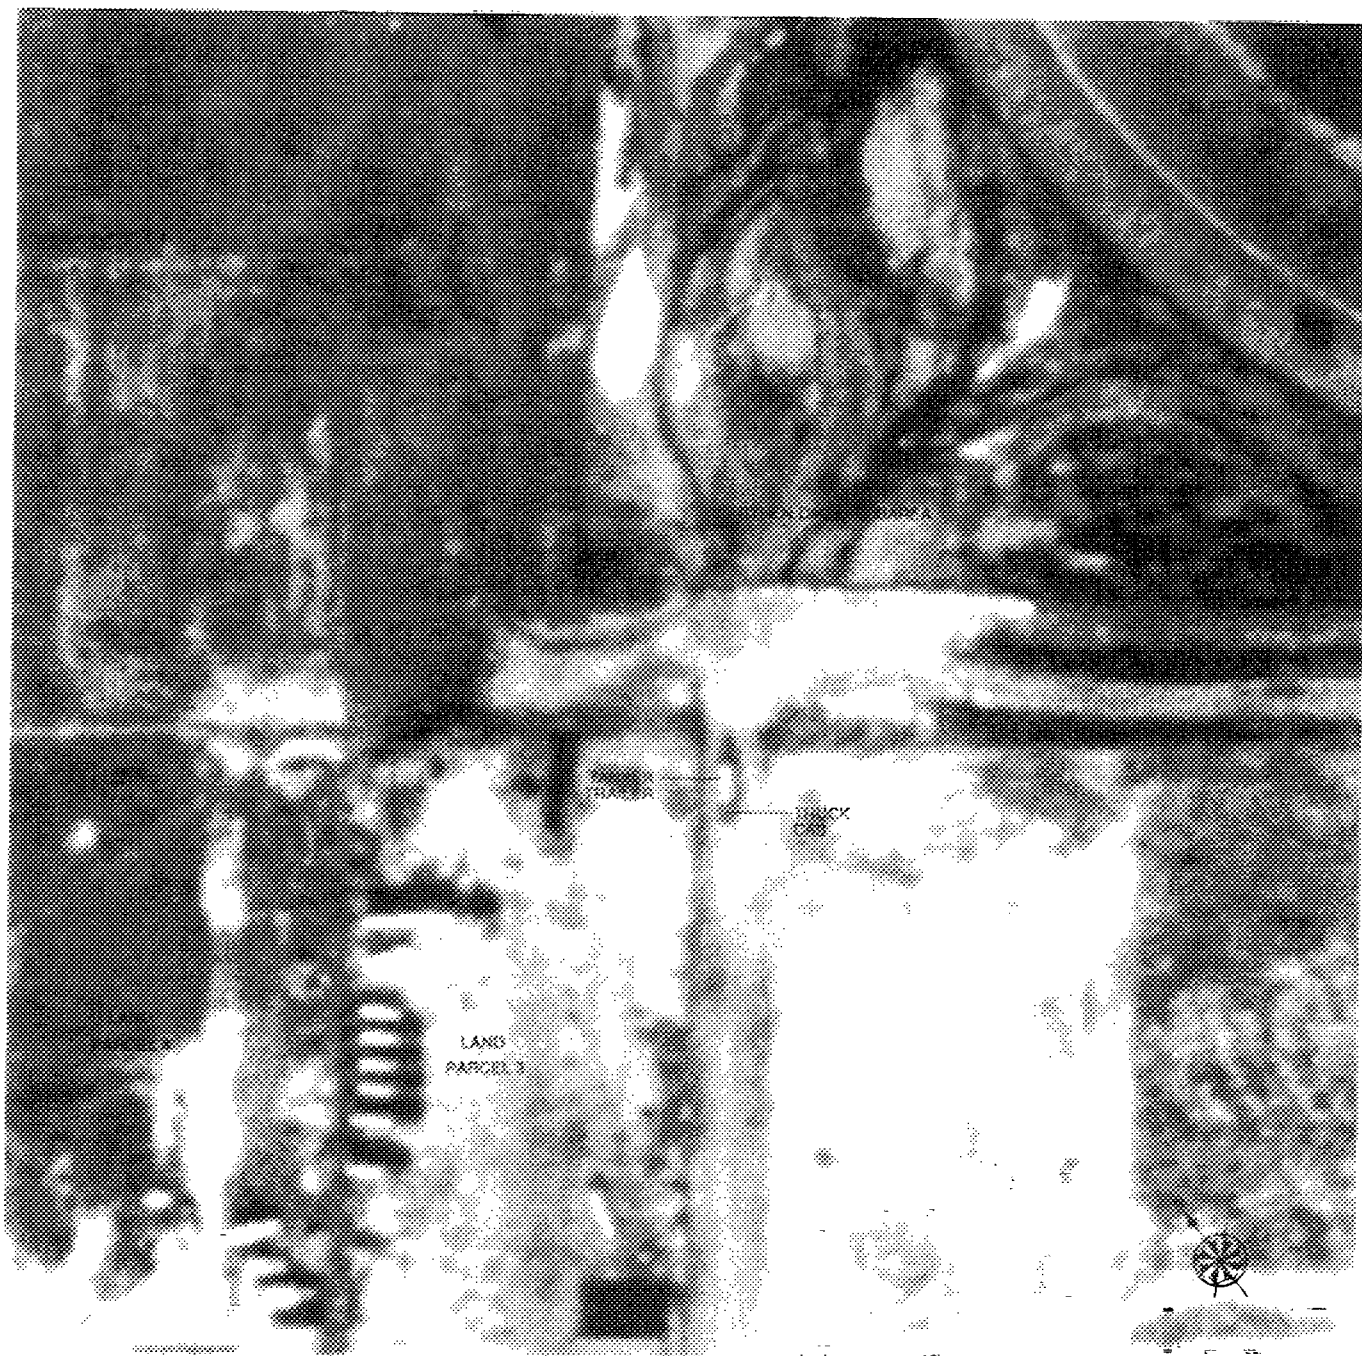
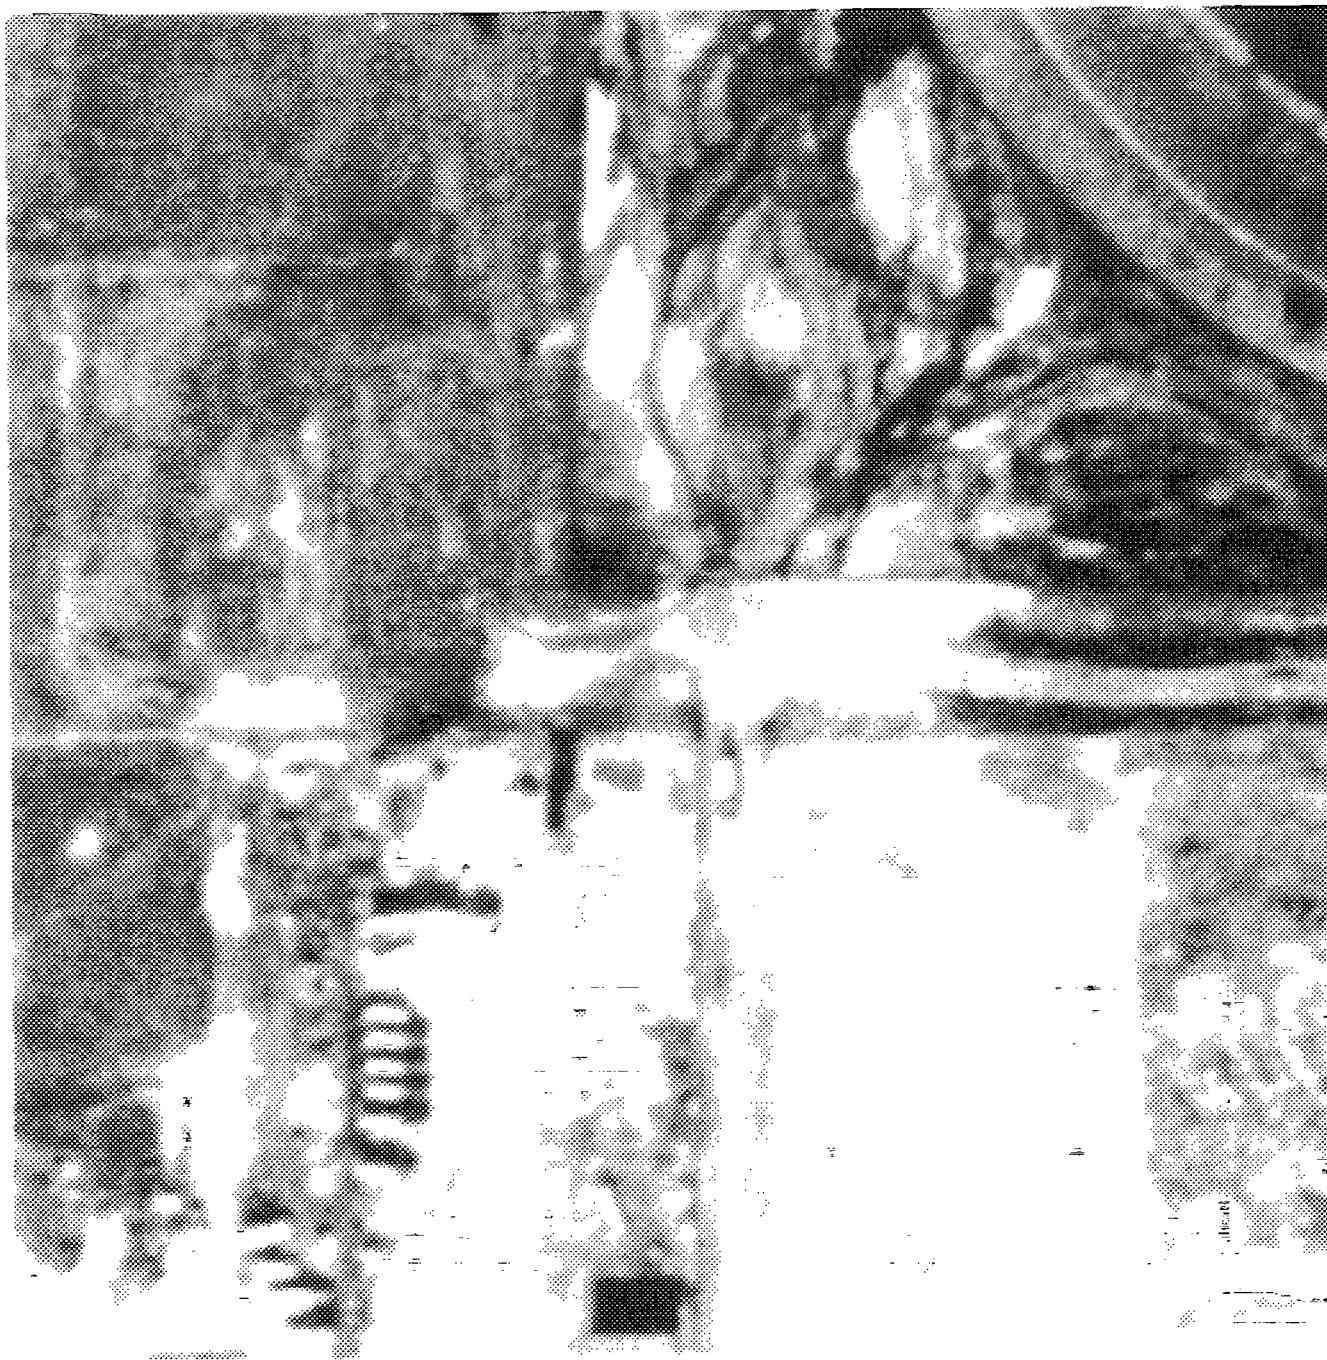
Moist fill (possible spillage) is noted near two waste disposal points at the southern and western corners of the Earthen-Diked Subarea. Standing liquid is seen near Los Nietos Road. Two small drainageways and an area of standing liquid are noted near the western corner of the Earthen-Diked Subarea. One drainageway leads to the northwest (see discussion under the Northwest Subarea heading); the other drainageway flows southeast to a small area of standing liquid. A tanker truck is present along the access road leading to the waste disposal point at this location. On the July 27, 1951, photograph (Figure 21) a tanker truck is backed up to this waste disposal point and dark-toned liquid is seen next to the tanker. This suggests that the tanker is discharging liquid material into the Earthen-Diked Subarea.

Figure 20. Waste Disposal, Inc., site, Tanker on road at western corner of the Earthen-Diked Subarea, February 25, 1951. Approximate scale 1:960.

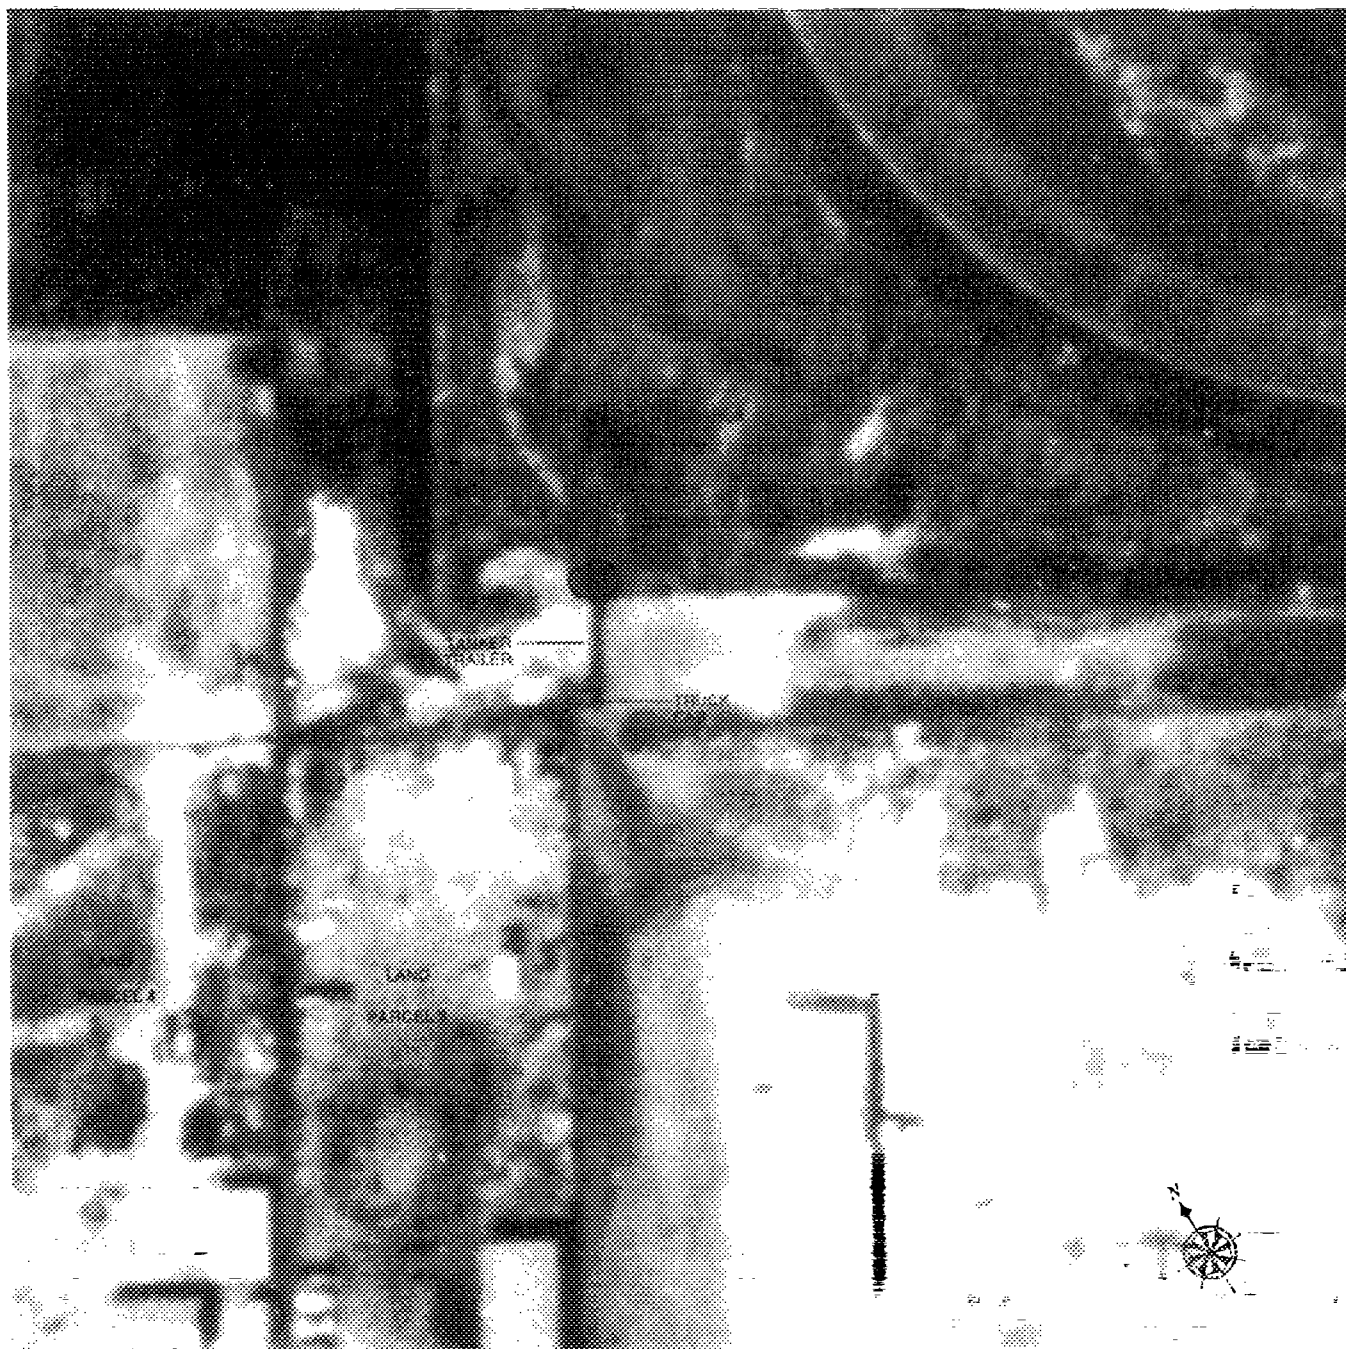
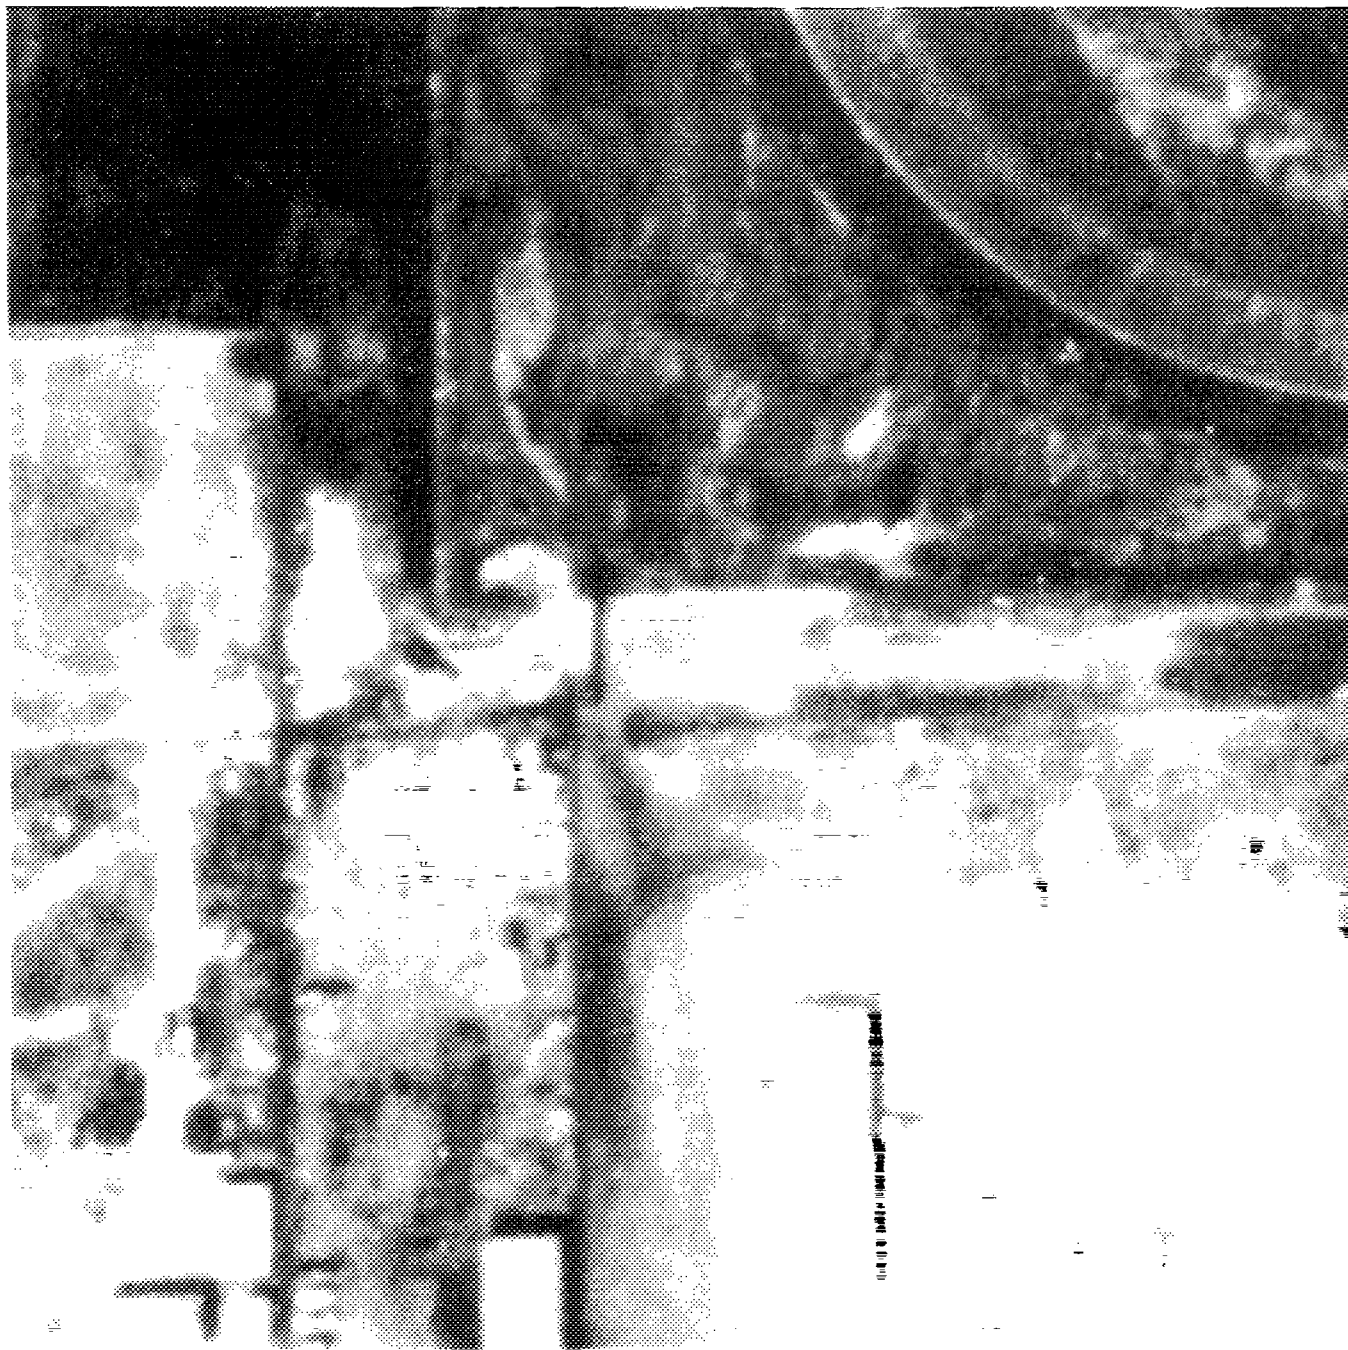
Figure 21. Waste Disposal, Inc., site, Tanker parked at western corner of the Earthen-Diked Subarea, July 27, 1951. Approximate scale 1:1,150.
